Evaluation Report

Hesston 560 Round Baler

PAMI

HESSTON 560 ROUND BALER

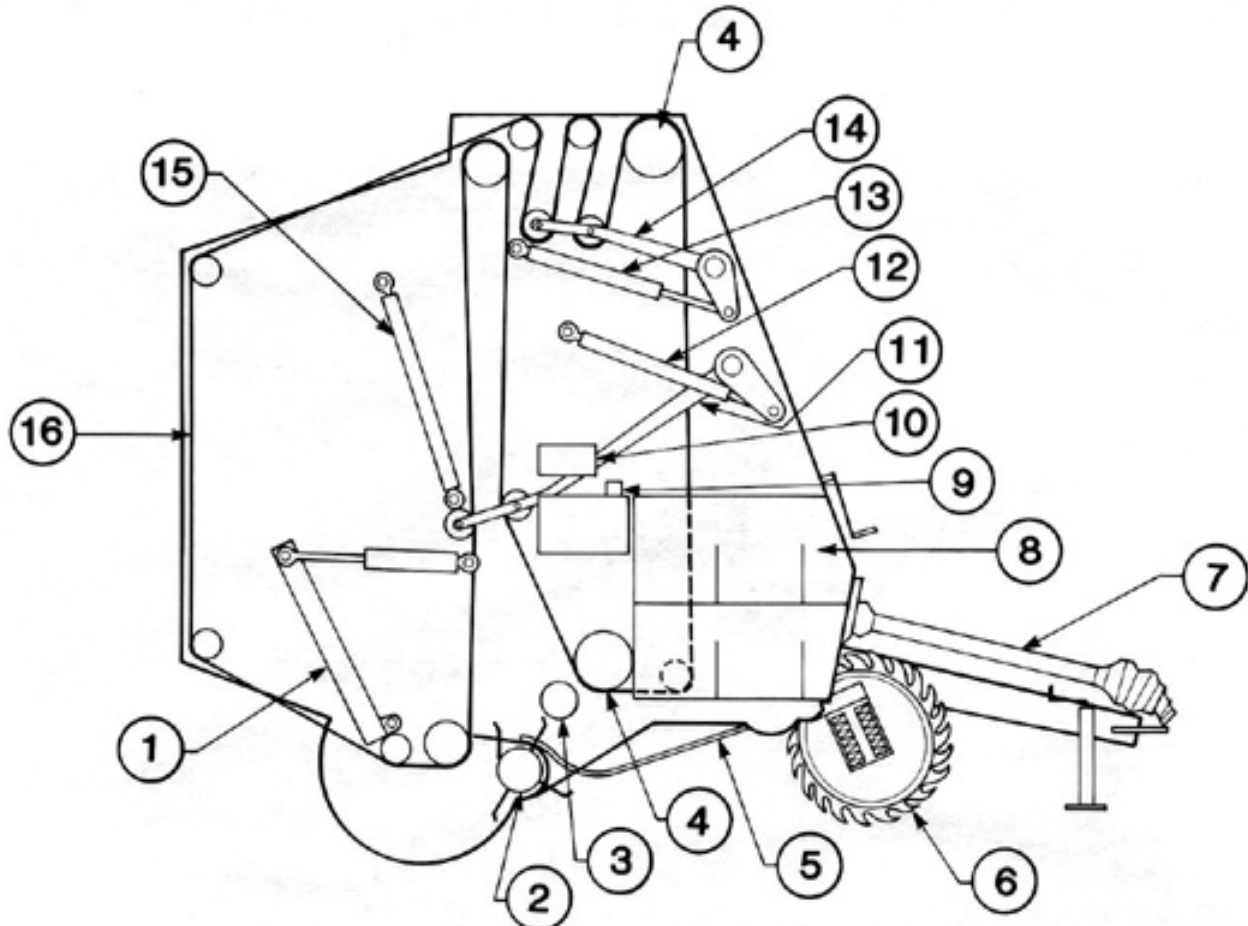
FIGURE 1. Hesston 560 Round Baler: (1) Bale Ejector Bar, (2) Pickup, (3) Starting Roller, (4) Crowned Driving Rollers, (5) Windguard, (6) Gathering Wheel, (7) Drive Shaft, (8) Twine Box, (9) Hydraulic Oil Reservoir, (10) Hydraulic Valve Control Block, (11) Bale Tension Arm, (12) Bale Tension Cylinder, (13) Belt Tension Cylinder, (14) Belt Tension Arm, (15) Gate Cylinder, (16) Forming Belts.

Detailed specifications are given in APPENDIX I. FIGURE 1 shows the location of major components and FIGURE 2 shows the monitor.

Bale density was controlled by two bale tension rollers (FIGURE 1). As the bale grew, it pushed up on these rollers. The rollers were mounted to a tension arm. The self-contained hydraulic system provided resistance to tension arm rotation which in turn provided pressure to the forming bale. The bale density was controlled by adjusting the relief valve pressure setting. Turning the control knob clockwise increased the bale pressure.

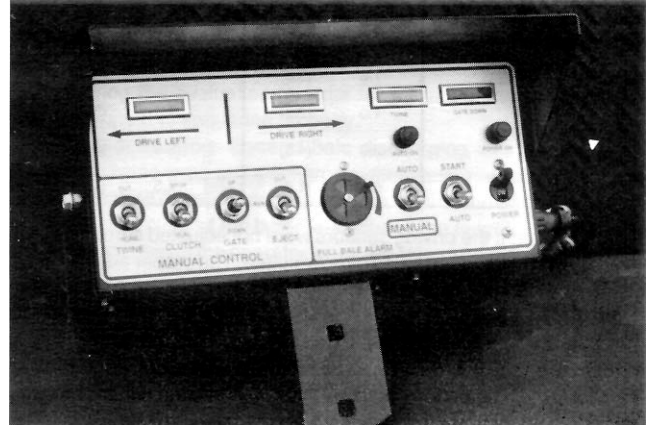
FIGURE 2. Hesston 560 Monitor.

monitor system also contains an audible alarm for indicating a full bale condition, a light to indicate when the tailgate is closed, a light to indicate when the twine is or is not feeding, and direction lights to instruct the operator which direction to drive in order to fill the width of the bale chamber uniformly.

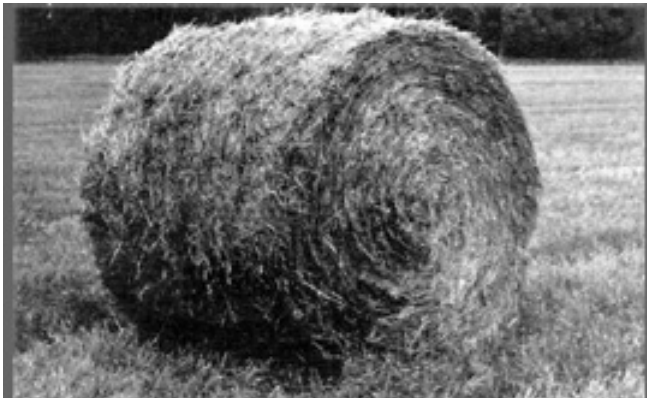
FIGURE 3. Typical Round Bale.

Bale Quality: Bale quality was generally excellent. The Hesston 560 produced firm, durable bales with flat ends and uniform diameter in all hay and straw crops (FIGURE 3). With the driving sensors set correctly, the operator could follow the direction lights on the monitor to produce

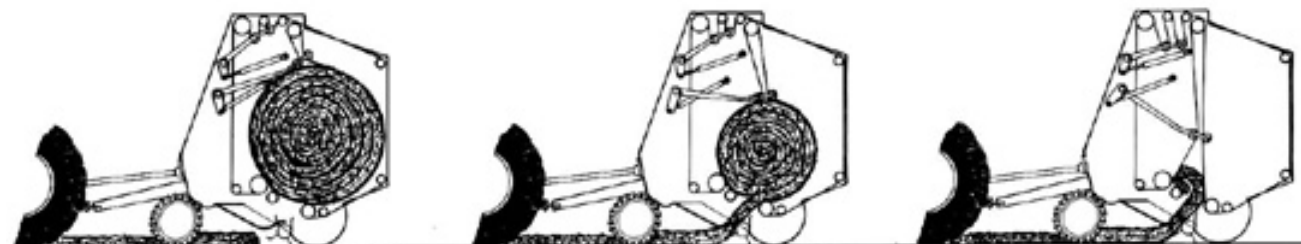
FIGURE 5. Stages of Bale Formation: (Left) Starting Bale, (Centre) Partially Completed Bale, (Right) Completed Bale.

Bale Forming: Ease of bale formation was very good. The forming belts aggressively conveyed the crop into the bale chamber from the pickup creating a positive feeding and forming action. The core was formed by initially feeding the centre of the baler followed by two quick left and right swings of the baler to feed the edges of the bale chamber. Then the direction lights could be followed to feed the width of the bale chamber uniformly which produced bales of uniform diameter. FIGURE 5 shows the stages of bale formation in the Hesston 560.

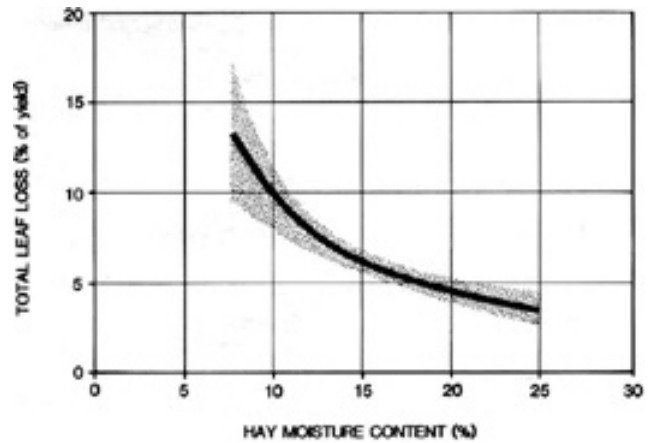
FIGURE 4. Typical Round Baler Leaf and Stem Loss in Mixed Alfalfa, Crested Wheatgrass and Bromegrass.

The importance of baling at a high moisture content on losses can be noted in FIGURE 4. This figure represents an accumulation of previous data for several round balers showing the total measured leaf and stem loss over a range of moisture contents in fields of mixed alfalfa, crested wheatgrass and bromegrass. Although the Hesston 560 was tested in a different crop, its total measured leaf loss was less than that presented in the figure.

FIGURE 4 does not include the relative effects of baling unconditioned or light windrows. Heavy, conditioned windrows are important to minimize losses. Lowering the PTO speed is effective in reducing the number of times the bale turns in the chamber, and consequently reduces leaf loss.

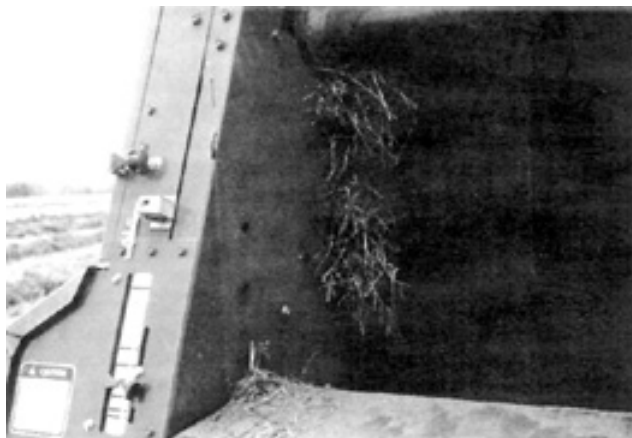
FIGURE 6. Crop Running up the Outside Forming Belt.

The baler plugged occasionally when baling short, dry crops in windy conditions. The wind blew dry crop between the driveline shield and the forming belts at the front of the baler, thereby allowing crop to collect on the twine knife shield. The forming belts then carried the collected crop up the front right side of the baler (FIGURE 6), where the crop found its way behind these belts and onto the bottom drive roller. Here the crop wrapped around the right side of the bottom drive roller and in time forced the belts to bear into the starting roller (FIGURE 1), which activated the main drive clutch. This problem occurred in both hay and straw. It is recommended that the manufacturer consider modifications to prevent crop from being carried behind the forming belts above the twine knife shield and subsequently wrapping around the right side of the bottom drive roller.

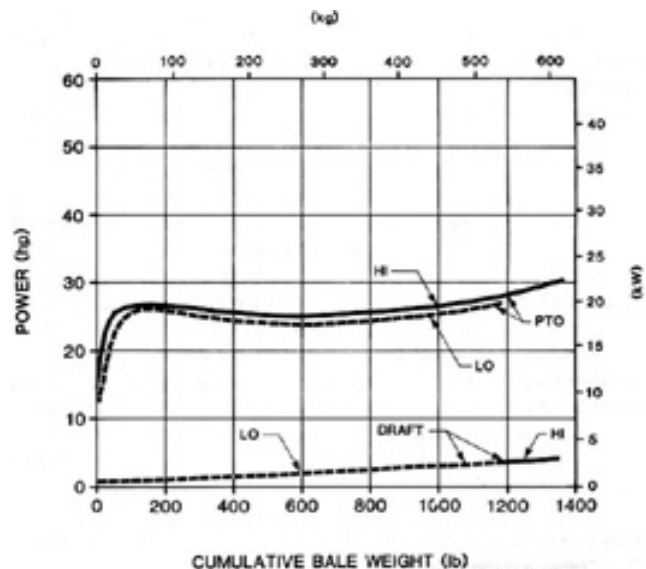
FIGURE 7. Typical Power Consumption During Bale Formation in Alfalfa (HI) High Density Bale, (LO) Low Density Bale.

Power Requirements: FIGURE 7 shows typical PTO and drawbar power requirements for the Hesston 560 at a workrate of 12.2 ton/h (11.1 t/h) and 14.2 ton/h (12.9 t/h) for a high and low density bale respectively. The power input is plotted against the bale weight to show the power requirements while each bale is formed. The curves are an average of the highly fluctuating measured PTO data which varied from 12 to 16 hp (9 to 12 kW) at no load to a maximum of 37 hp (28 kW) in alfalfa for full sized bales. Drawbar requirements at 5.5 mph (9 km/h) were about 3.5 hp (2.6 kW) and 4.0 hp (3.0 kW) when the bale reached full size for low density and high density bales respectively. Although maximum horsepower requirements did not exceed 41 hp (31 kW), additional power was required to suit other field conditions such as soft and hilly fields. To fully utilize baler capacity, PAMI recommends a

tractor of at least 65 hp (49 kW) in order to have sufficient power reserve in all field conditions.
